Manhole Inspection Summary

Manhole # S37YY_037MH

Location Address: **600 33RD ST**

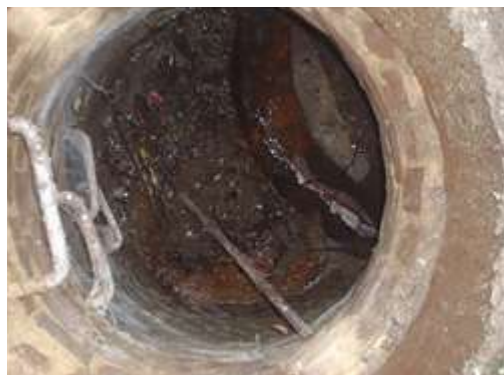
Top View

Bench debris.

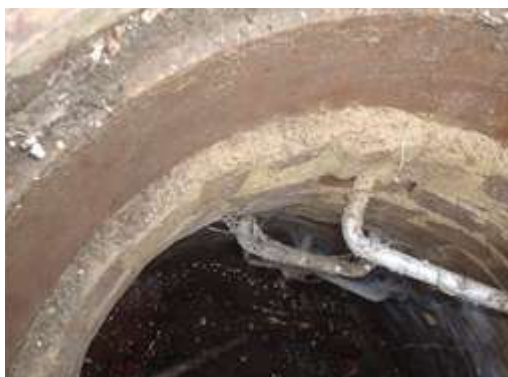
Defect

☒ **Leaks**

Infiltration: ☐ None ☒ **Joint** ☐ Cracks ☐ Mortar ☐ Roots ☒ **Wall**

Condition: ☐ Sound ☐ Cracked ☒ **Root Intrusion** ☐ Loose Brick ☐ Deteriorated

Infiltration: ☐ None ☐ Joint ☐ Cracks ☐ Mortar ☒ **Roots** ☒ **Wall**

Frame leaks. Adjustment infiltration.
Barrel root intrusion and infiltration.

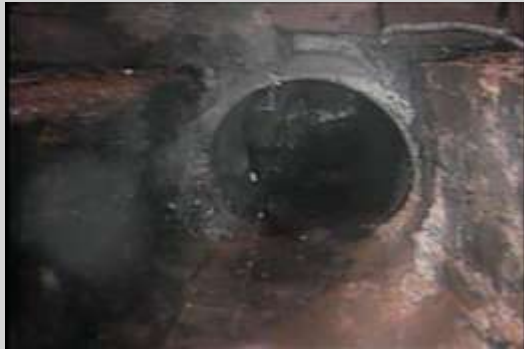
8 in. Circular Gravity Sewer Pipe Out @ 12 O'Clock

Deposits: ☐ None ☒ **Mud** ☐ Sludge ☐ Debris ☒ **Grease**

Silt Depth: **0** (in.) Deposits Extent: **Light**

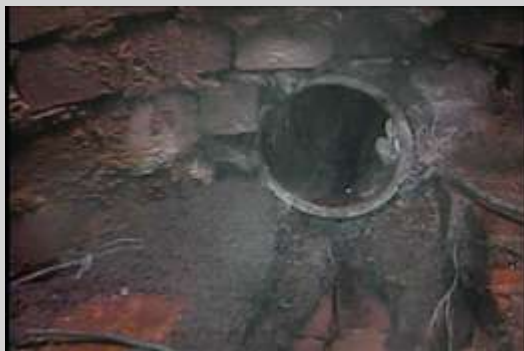
6 in. Circular Gravity Sewer Pipe In @ 4 O'Clock

Infiltration: **Evidence** Pipe Seal Cond: **Unknown**
